# Manhole Inspection Summary

Manhole # S21G1\_013MH

Insp Date: **4/29/08 10:58 AM**

**Location** Address: **2503 puget st**

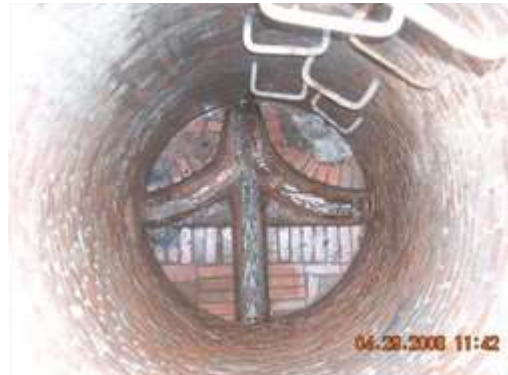
Top View

bench debris

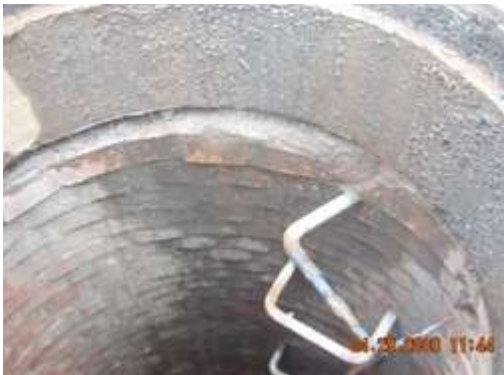
Defect 2

Subject To Ponding: **Sheeting**

Infiltration: ☐ None ☒ **Joint** ☐ Cracks ☐ Mortar ☐ Roots ☐ Wall

infiltration at chimney frame joint, inflow  
evidence from sheeting

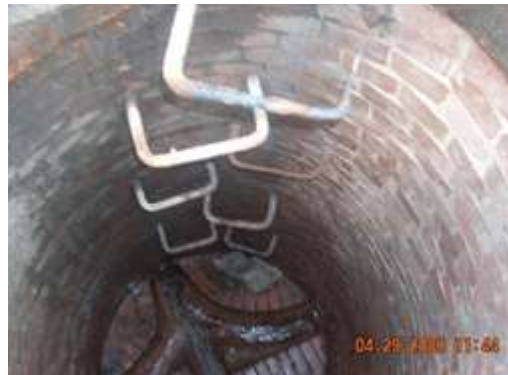
Defect 1

Count: **7** Missing: **0** ☒ **Corroded**

corroded steps

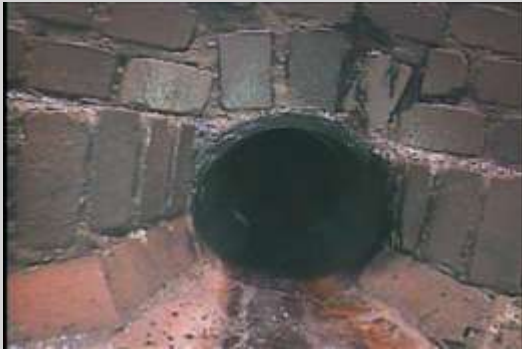
12 O'Clock Outflow

Pipe Height: **8.4** (in.) Rod and Bar (Angled)  
Pipe Material: **Clay** ☐ Pipe Lined  
Invert Depth: **10.86** (ft.) Flow Characteristics: **Slow**  
Deposits: ☒ None ☐ Mud ☐ Sludge ☐ Debris ☐ Grease  
Silt Depth: **0** (in.) Deposits Extent:  
Infiltration: **Evidence** Pipe Seal Cond: **Sound**

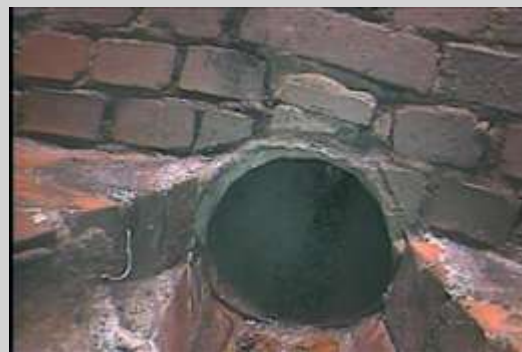
Drop In @ 9 O'Clock

Drop: **Outside** Rod and Bar

Angled: **Yes** Reading: **9.30** (ft.)

Inv Depth: **10.30** (ft.)

Drop Condition: **Open**
